Lakeside Area Mobility and Safety Improvements

Henrico County

May 2023

Lakeside Area Mobility and Safety Improvements Study

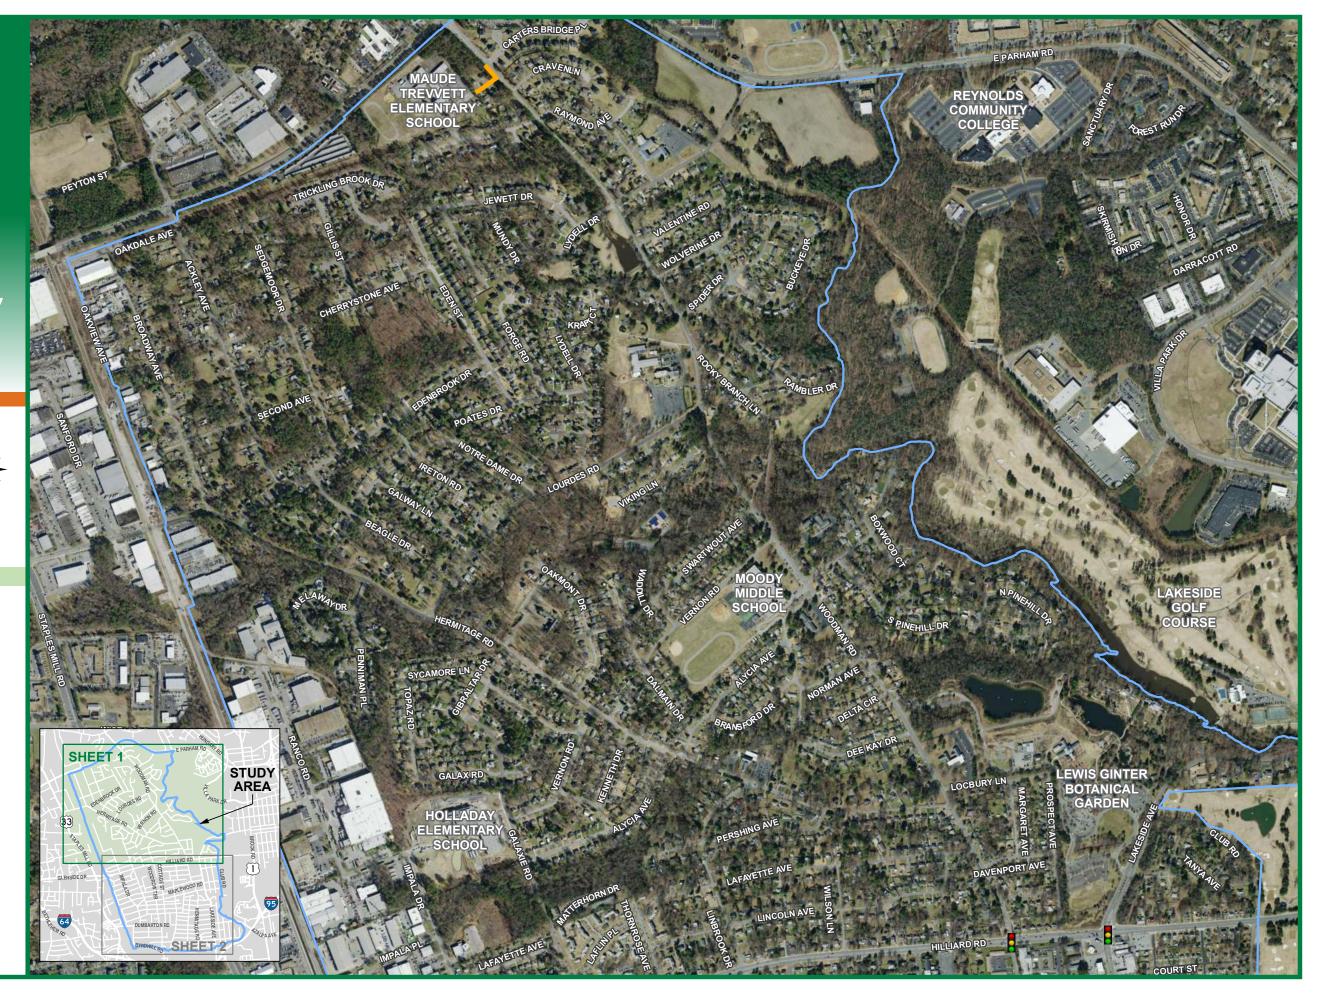
Figure 1:
Ongoing and
Recently
Completed
Projects

ONGOING PROJECTS

Maude Trevvett Elementary Sidewalk Connection

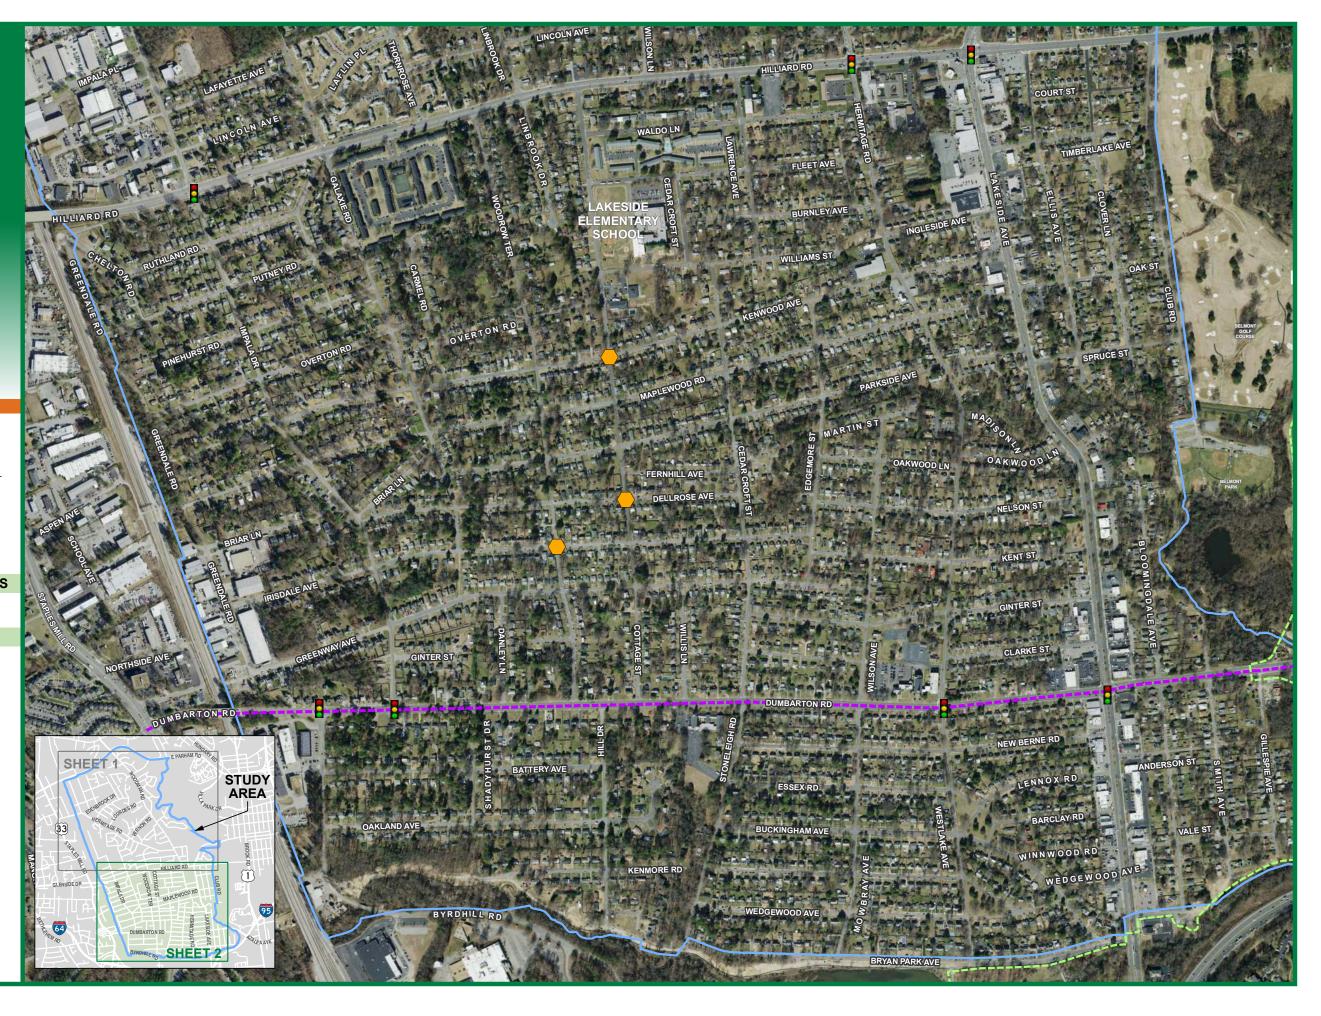
Figure 1: Ongoing and Recently Completed Projects

RECENTLY COMPLETED PROJECTS

Stop Sign Reconfiguration

ONGOING PROJECTS

Dumbarton Rd Safety and Mobility Improvements

---- Fall Line Trail

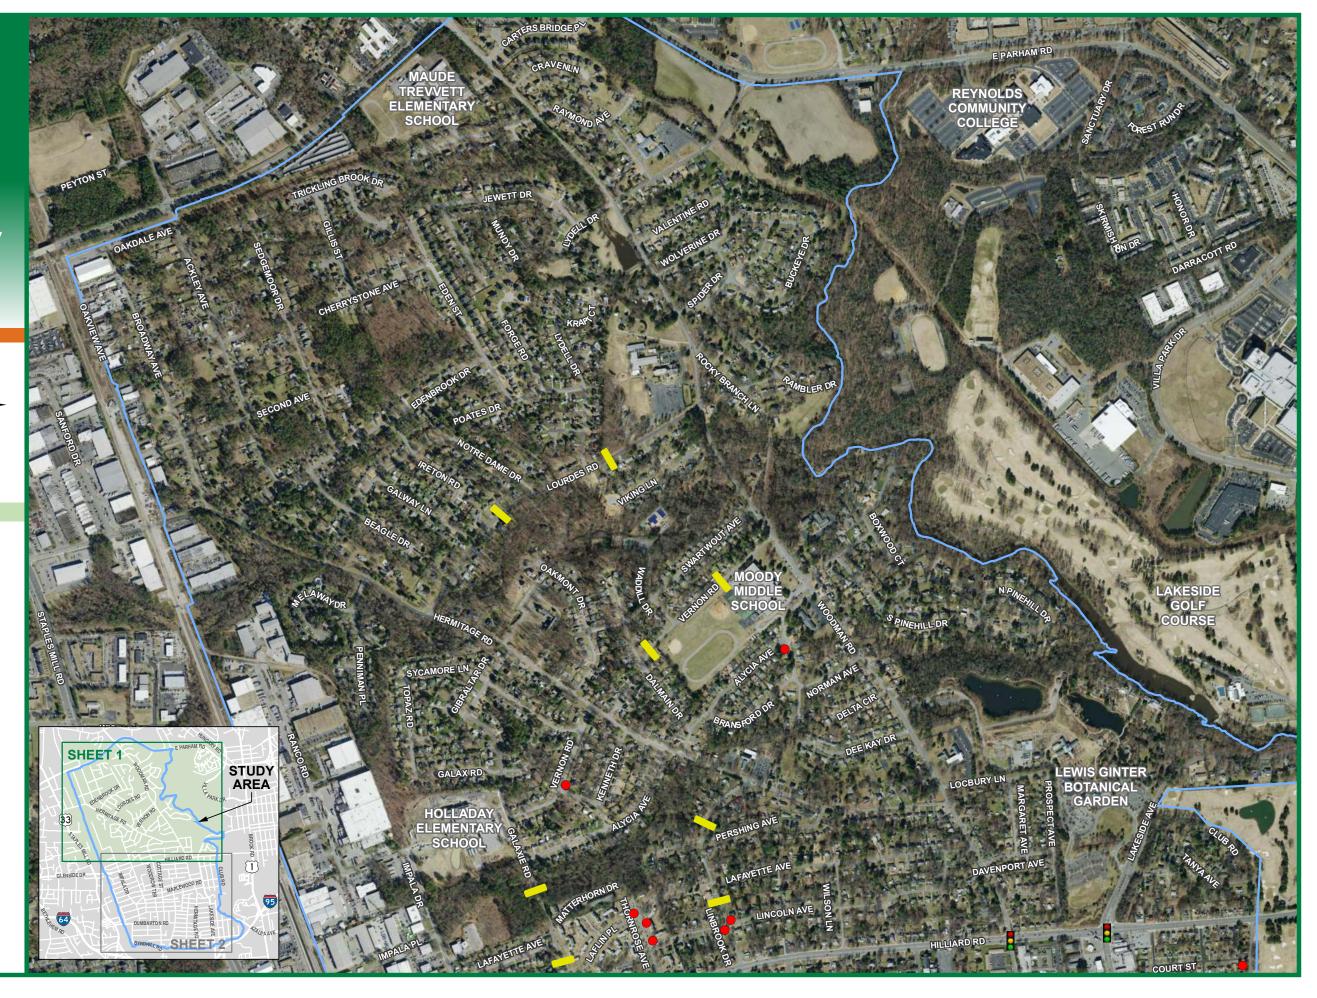
Figure 2: Short-Term Improvements

SHORT-TERM IMPROVEMENTS

- Install Speed Humps
- Replace Yield with Stop Sign

Summary of Recommendations: Based on the feedback received at the Public Information Meeting, field observations, and StreetLight data, the study team, in conjunction with the County, identified both short-term and mid-term/long-term improvement recommendations. **Table 1** summarizes the proposed improvements. **Figure 1** depicts Ongoing and Recently Completed Projects, **Figure 2** depicts Short-Term Improvements, and **Figure 3** depicts Mid-Term/Long-Term Improvements.

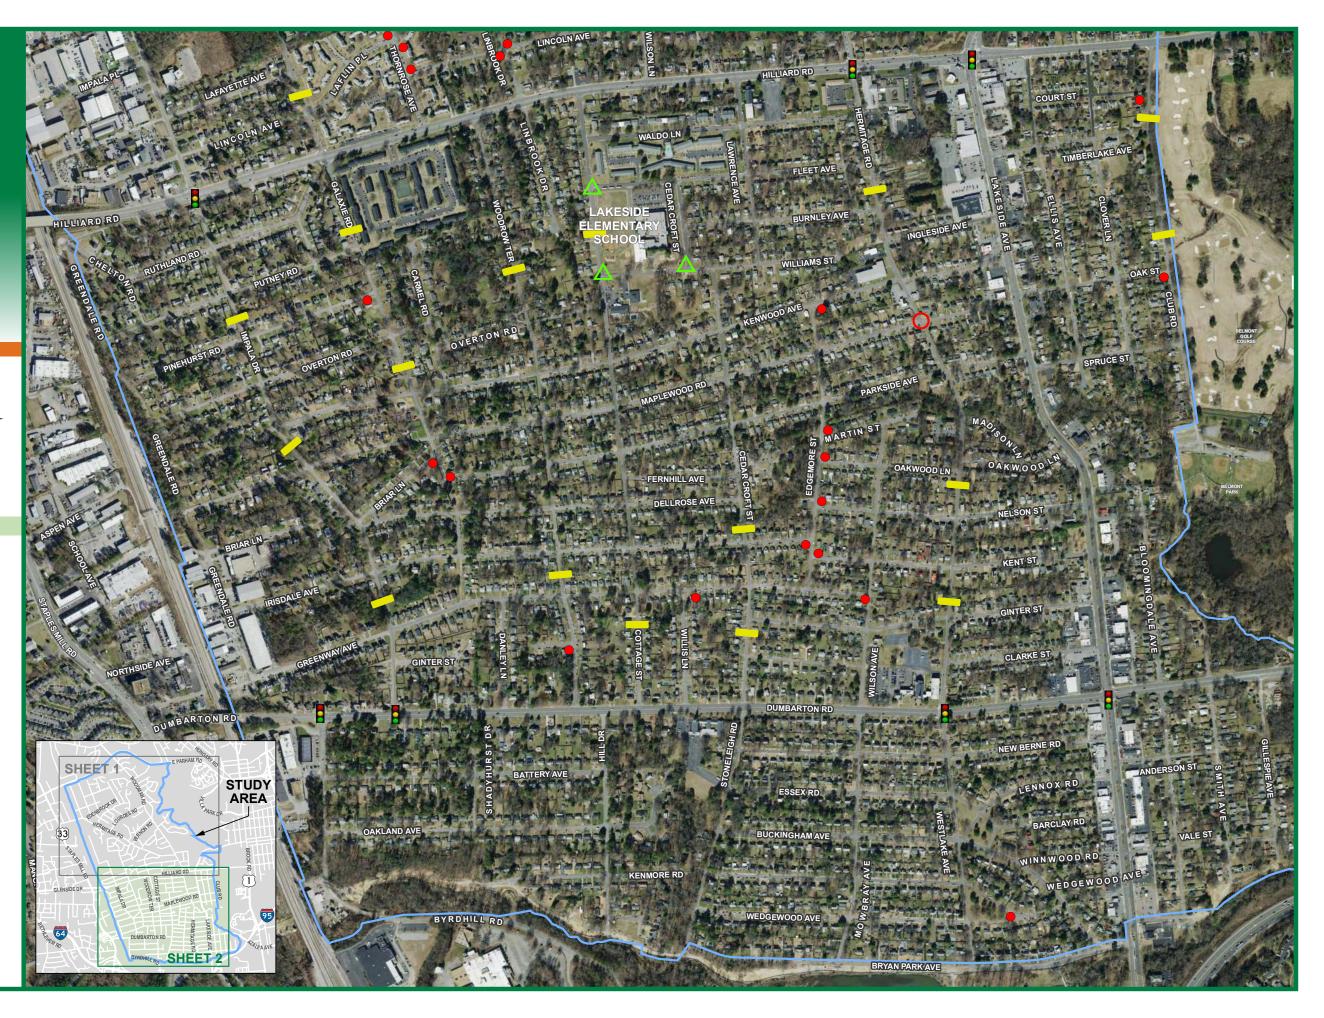
Figure 2: Short-Term Improvements

SHORT-TERM IMPROVEMENTS

- Install Speed Humps
- Replace Yield with Stop Sign
- O All-Way Stop Control
- △ Drainage Improvements

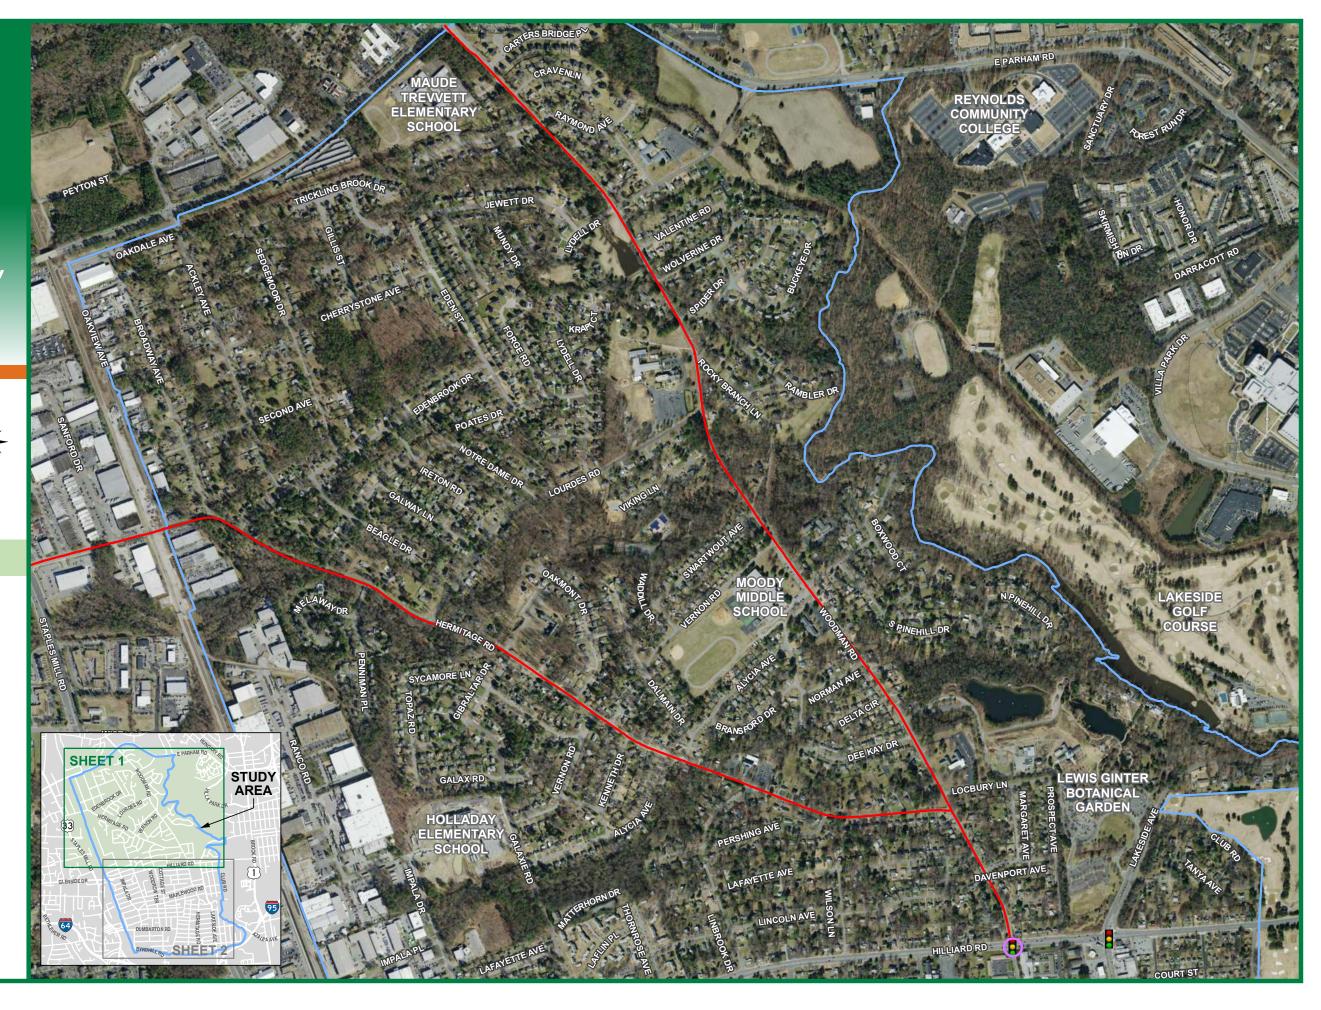
Figure 3: Mid-Term/ Long-Term Improvements

MID-TERM/LONG-TERM **IMPROVEMENTS**

Priority Sidewalk and Traffic Calming Segment

Install Signalized Pedestrian Crossings in Collaboration with VDOT

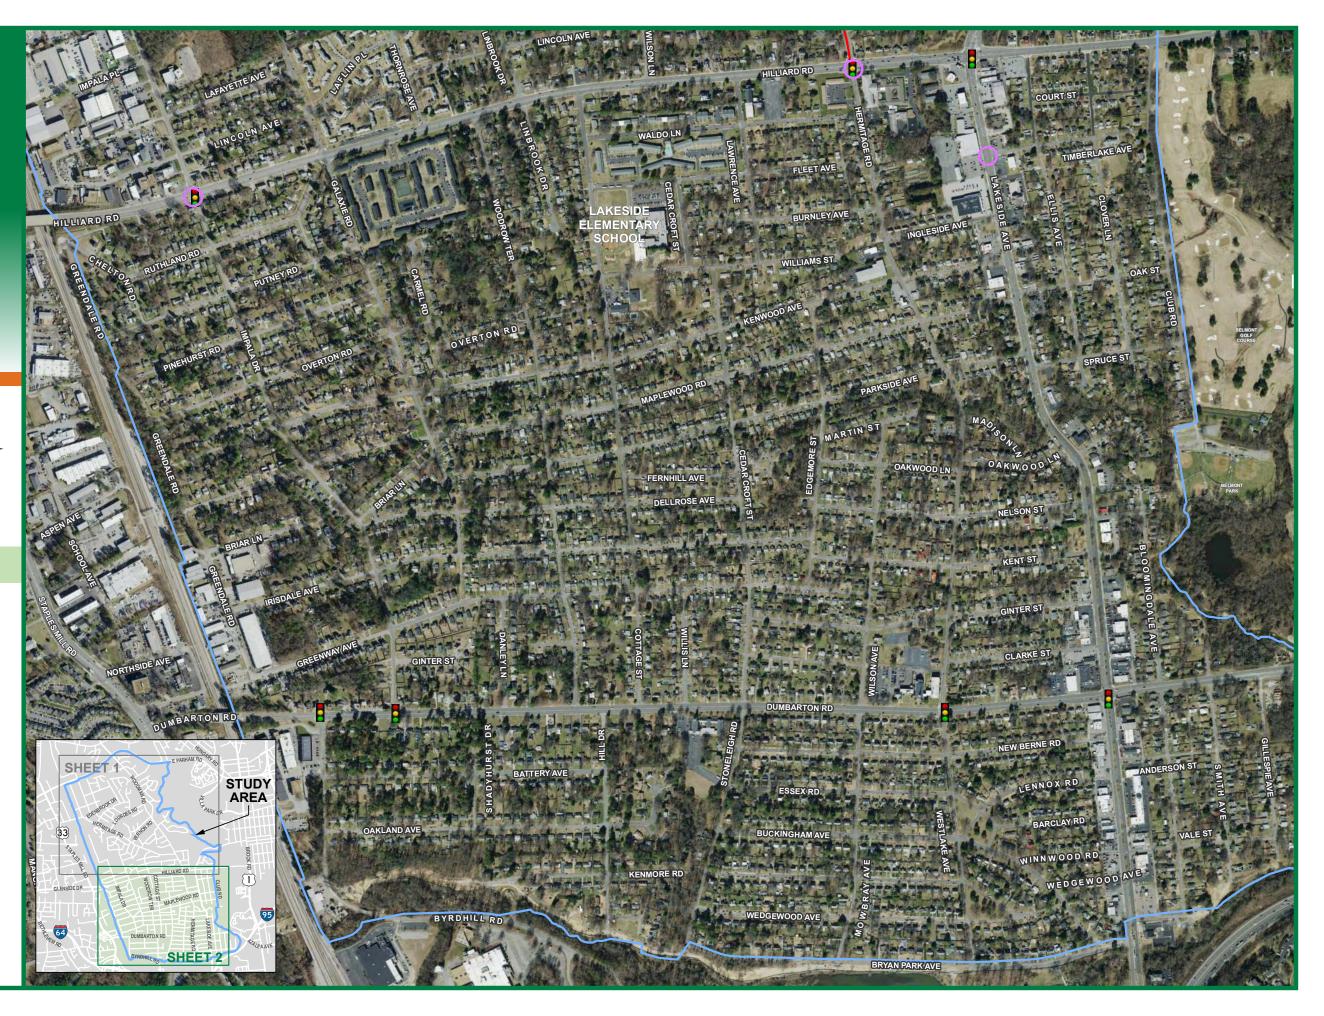
Figure 3: Mid-Term/ Long-Term Improvements

MID-TERM/LONG-TERM IMPROVEMENTS

Priority Sidewalk and Traffic Calming Segment

Install Signalized Pedestrian
Crossings in Collaboration
with VDOT
